Re: SP-16-00001

Thank you for the opportunity to comment on the short subdivision of approximately 81.14 acres into three 20 acre lots and one 21.14 acre lot, proposed by Ron and Deborah Mitchell. We have reviewed the application and Ecology asks that you consider these late comments.

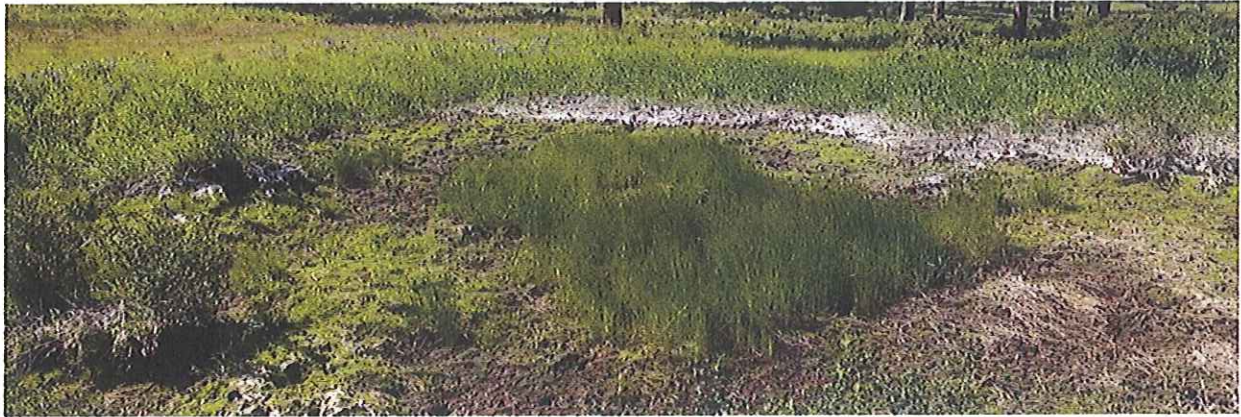
The result of our review is that there are likely to be wetland areas that are associated with the type 9 stream system that flows through the parcel, which is located primarily within proposed parcel 4B. The submitted critical areas checklist states that there are no wetlands on site. Was the site surveyed by a professional wetland scientist?

A close up clip from one of the photos submitted to Ecology via e-mail by a concerned neighbor is shown below. The location of the photo was purported to be in the vicinity of a proposed roadway and is possibly located within the drainage swale which is on site. The photo looks like it could be of a wetland area, given high water marks and wetland vegetation. Ecology has not been on site to verify soil conditions or the presence of this wetland in the corridor.

Ecology recommends that before any development (residences and other necessary infrastructure to support the residential development on site such as roads, utilities, septic, wells, etc.) occurs within these proposed parcels, that the development footprint and buffer areas are reviewed by a wetland professional to assure that wetlands are not directly or indirectly impacted. These proposed lots are of such large size that it should be easy for applicants to assure that construction clearing, wells, septic systems and roads are not placed within wetlands or within their required buffer areas.
