SITE SURVEY of LOT 18, BLOCK 2
Plat of Sun Country Estates @
581 Pebble Beach Drive

record survey for
by

R.L. BAILEY & ASSOCIATES
4201 HWY 970, CLE ELUM, WA 98922
509 674 5551

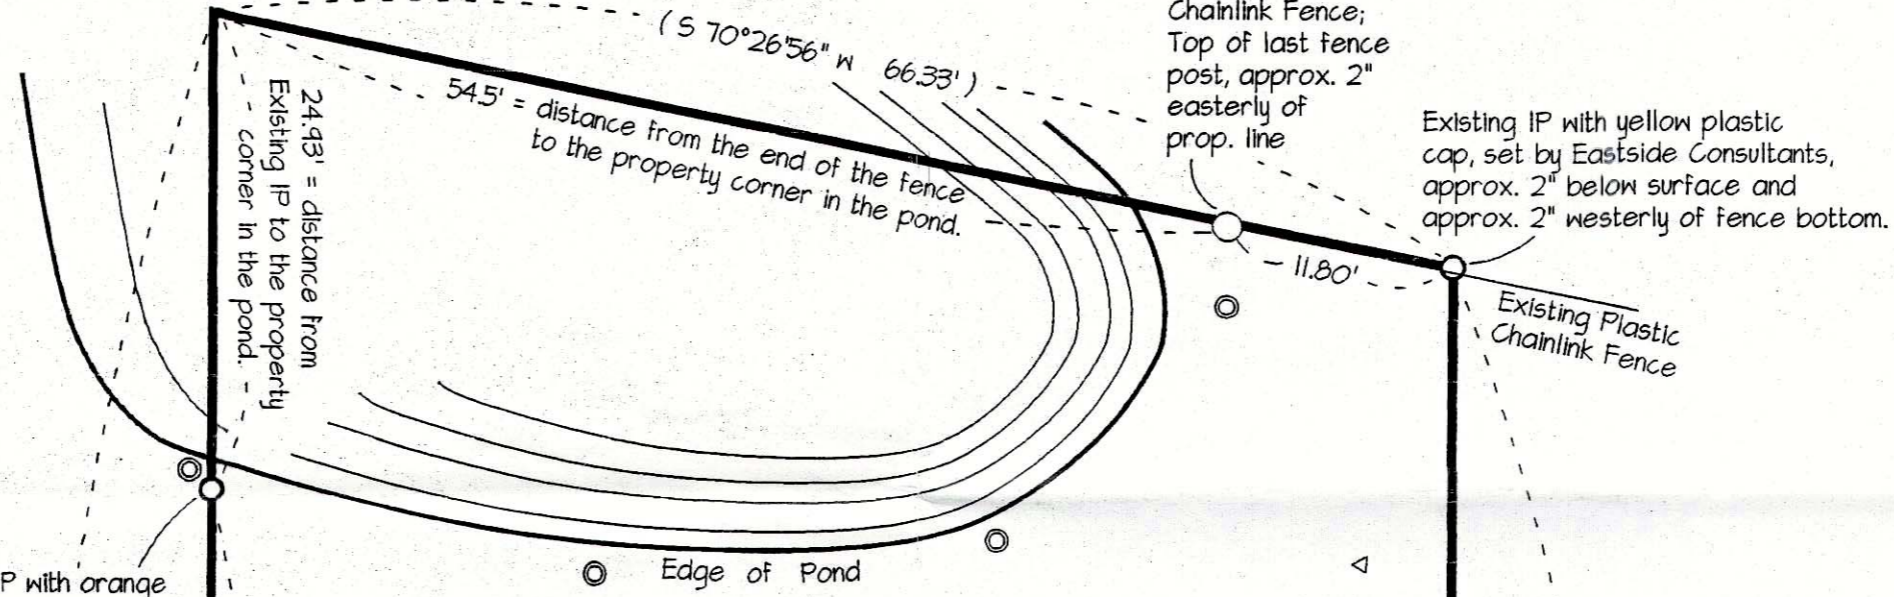
Calculated Position of the SW corner of Lot 18, Blk 2; Position is located in the pond, no corner set.

Existing IP with orange plastic cap, approx 2' below surface, set by Eastside Consultants. Located beneath grand-fir.

Existing IP with yellow plastic cap, set by Eastside Consultants, approx. 2' below surface and approx. 2' westerly of fence bottom.

Fence line is approx. 5' north of prop. line.

Existing IP with old plastic cap, 3" to 4" below surface of parking area...marked with more ribbon and pink "whisker".

Existing 3/4" IP underneath branches of a small grand-fir, approx. 12" in height.
